Manhole Inspection Summary

Manhole # S25C__032MH

Insp Date: **8/3/07 7:29 AM**

Location Address: **1203 MULBERRY ST**

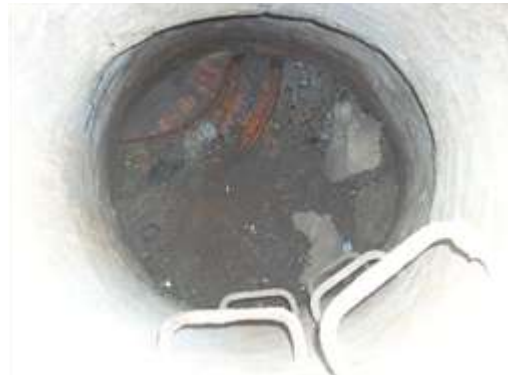
Top View

abandoned pipe at i9

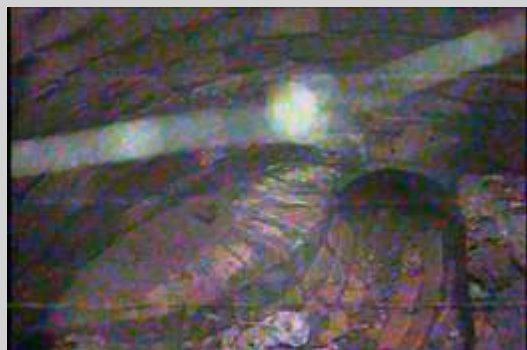
12 O'Clock Outflow

10 in. Circular Gravity Sewer
Pipe Out @ 12 O'Clock

Infiltration: **None** Pipe Seal Cond: **Sound**
